BELZONA REPAIRS JACK HAMMER BASE IN PRIMARY CRUSHER

ID: 5559

Customer Location: Mine, Carajás, Brazil

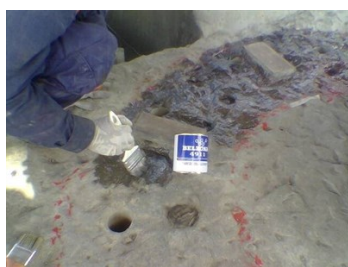
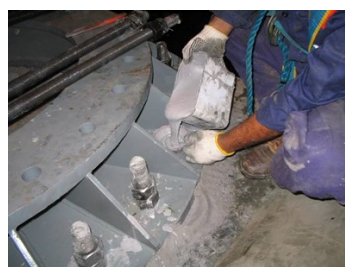
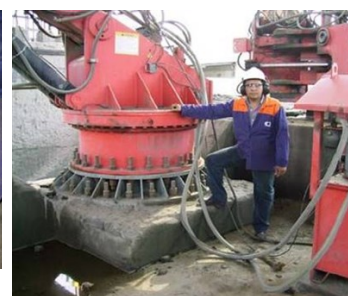
- * Concrete base with the cut bolts ,
- * Conditioning of the concrete base with Belzona 4911 ,
- * Application of Belzona 4111 and Belzona 4151 at the installation of the bolts in the holes ,
- * Repair of the base, completed ,

The bolts at the base of the jack hammer suffered from shear stress resulting in loosening of the base and possible fall from the equipment inside the hopper of the primary crusher.

Some holes were made with a diamond-tipped bit to a depth of 1,250 mm to install new bolts. The concrete base and the open holes were cleaned with soap and water to eliminate any residual oil or grease. The area was adequately dried and cleaned. Later Belzona 4911 was applied at the base of the concrete as well as in the open holes. The base was leveled with Belzona 4111, leaving an opening of 0.5 cm between the block and the base. After grit blasting the metal to a near white finish, the surface was cleaned and conditioned, the base of the jackhammer and the bolts were installed over the base. Belzona 4111 and Belzona 4151 were applied in the housing of the bolt and were injected between the concrete base and the other metallic base of the jack hammer.
