Belzona Propeller Repair - Tugboat

ID: 556

Industry: Marine
Application: SOS-Ships and Offshore Structures

Customer Location: Port Authority, Egypt
Application Date: June 2005

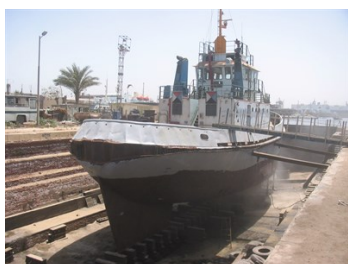
- * General view of the tugboat ,
- * Erosion-corrosion evident ,
- * Surface after blasting ,
- * Application of Belzona to protect the propellers ,

Voith Schneider® Propellers on a large tugboat.

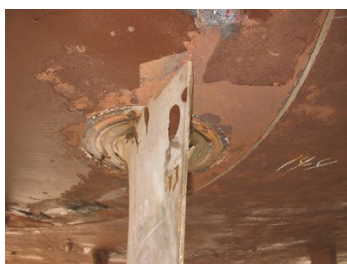
The propellers were severely corroded-eroded. A previous coating had failed; holes and pitting were found in many locations.

Welded joints were the most severely damaged areas, but additional welding to repair the problem would cause heat distortion and unacceptable delay in drydock. Belzona was the best solution to repair and protect this equipment.
