# Belzona Propeller Repair - Tugboat

ID: 556

Voith Schneider® Propellers on a large tugboat.

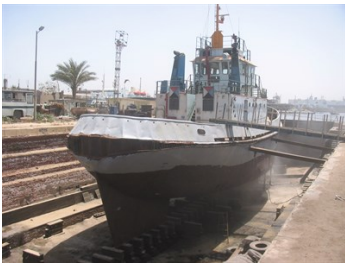
- \* General view of the tugboat ,
- \* Erosion-corrosion evident ,
- \* Surface after blasting ,
- \* Application of Belzona to protect the propellers ,

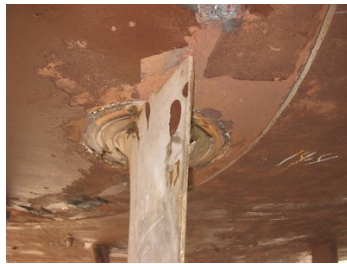
*The propellers were severely corroded-eroded. A previous coating had failed; holes and pitting were found in many locations.*

Welded joints were the most severely damaged areas, but additional welding to repair the problem would cause heat distortion and unacceptable delay in drydock. Belzona was the best solution to repair and protect this equipment.
