# BELZONA REPAIRS THE HYDRO PLANT INLET PIPE

ID: 5561

**Customer Location:** Hydropower plant, Usk, WA  
**Application Date:** March 2014

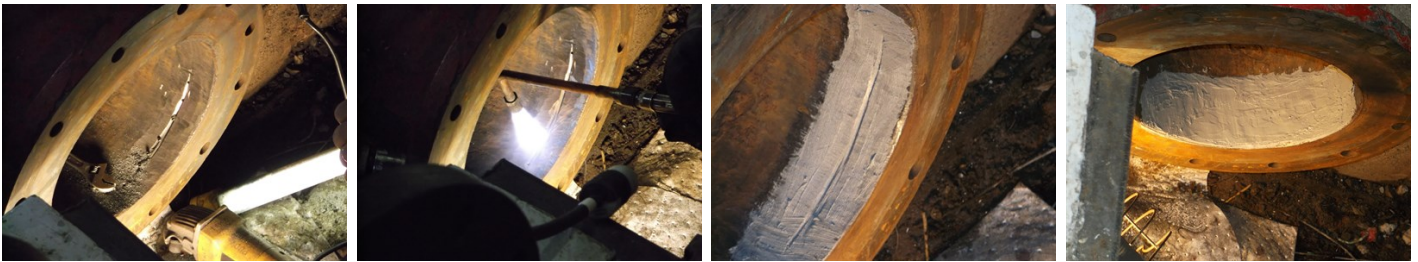
A nearby landslide had shifted the waterline inlet of the hydro project causing extreme pressure on the cast iron pipe near the inlet. This caused the pipe to begin splitting behind the flange due to misalignment.

- \* 1. Overview of "vee" out cracks and drilled holes with inserted screws ,
- \* 2. Sweating out with the rosebud torch ,
- \* 3. First layer of Belzona 1111 scrubbed in ,
- \* 4. Completed application ,

The surface was ground with a coarse grinding wheel to expose the full length of the crack. The crack was "vee'd" out and holes were drilled at each end all the way through, and 75% through every 1". The holes were then tapped and screws inserted and ground off flush to prevent movement in the crack. The area was sweated out with a rosebud torch, and a final surface preparation of grinding was done. Belzona 1111 was scrubbed into the surface and a thin layer applied before laying in a coated piece of Belzona 9341. The application was finished off with a final layer of Belzona 1111.
