BELZONA CORROSION PROTECTION FOR SUCTION SCRUBBER

ID: 5563

Customer Location: Oil and Gas Industry, North Sea, UK
 Application Date: 2003

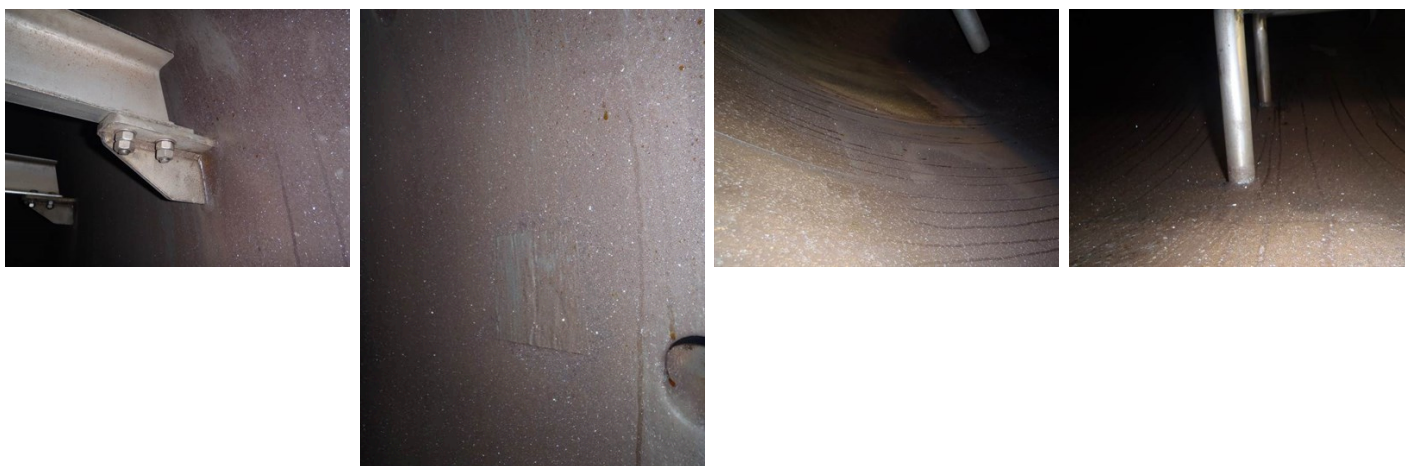
- * Inspection in 2013 - Inside view of the scrubber ,
- * Patch repair ,
- * Different view of patch repair ,
- * View around ladder ,

Belzona lining was specified to protect new process vessels and utility tanks. Based on Belzona track record since the 1990s, the customer opted for a carbon steel shell lined with Belzona rather than stainless steel cladding. During the 2013 inspection, it was reported that the Belzona lining was in excellent condition. Local repairs carried out during the initial application were still in very good condition with no sign of degradation.

The application was carried out in accordance with Belzona Know-How System Leaflets TCC-3 and TCC-5. Belzona 1522 applied by Plural spray and Belzona 1391 applied by hand to nozzles etc.
