# First Stage Separator: Seven Years of Problem-free Service from Belzona® 1591

Customer Location: Oil Rig - North Sea  
Application Date: 1998

New process package for the Janice oil field comprising test and first stage separators.

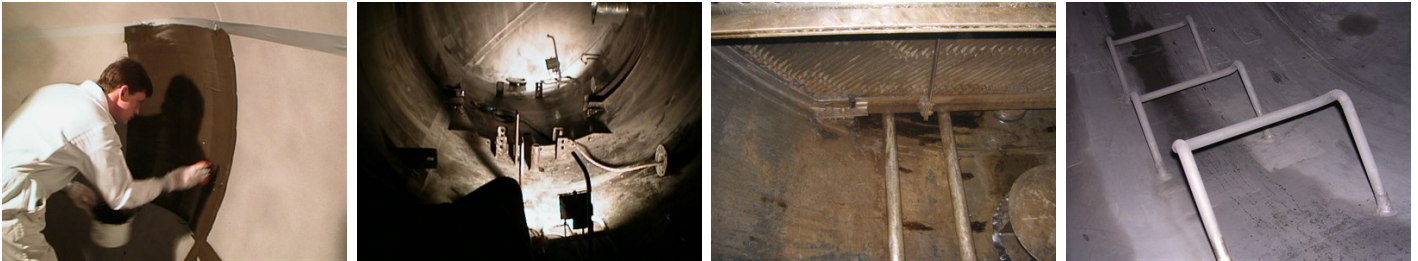
## Photograph Descriptions

- \* 1. & 2. & 3. Vessel being coated in 1998. ,
- \* 4. Vessel opened in 2005. ,

The use of a high temperature erosion-corrosion resistant coating allows separators and other vessels to be fabricated more cost effectively out of Carbon Steel rather than Stainless or Duplex Steel. After seven years of service, the Belzona® 1591 was found to be in excellent condition.

Coating required to provide resistance to high temperature process fluids which would generate corrosion and erosion issues.  
Design temperature was 150° C.

Application was carried out in accordance with Belzona Know-How System Leaflet TCC-5.
