# BELZONA SUPERWRAP II RESTORES PIPE AT DAM WALL

Industry: Water / Wastewater  
Application: VPF-Valves, Pipes and Fittings  
Substrate: Mild Steel  
Products: \* Belzona SuperWrap II ,  
\* Belzona 1981 Resins ,  
\* Belzona 9382 Release Film ,

Customer Location: National Water Company, Wales, UK  
Application Date: March 2015

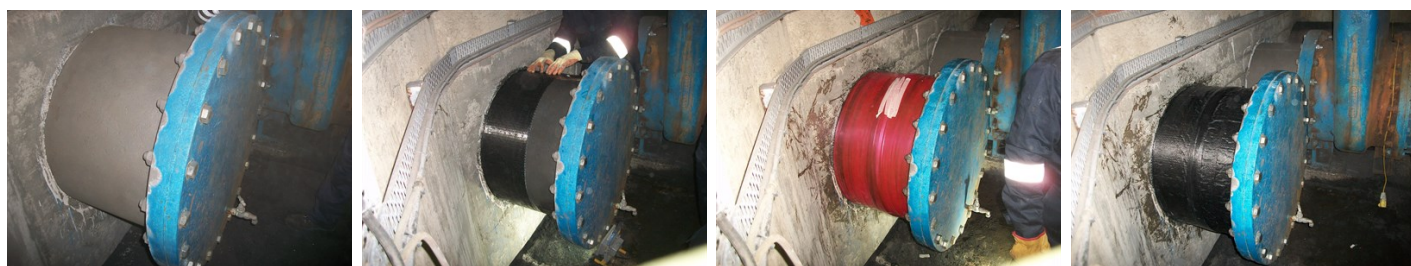
The pipe had suffered from corrosion over time which had caused the formation of pits on the surface of the steel. This resulted in weakening of the pipe wall and requirement to repair the steel. As the pipe cannot be shut off, an in-situ, cold applied repair was chosen.

- \* Pipe condition following grit blasting ,
- \* Initial wrap commencing ,
- \* Following complete system application, Belzona 9382 release film is applied ,
- \* Completed application with release film removed ,

The application was carried out as per the Belzona Superwrap II method statement provided. Following thorough grit blasting to the required standard, the Belzona Superwrap II system was applied. Once the required thickness and number of wraps were achieved, the repair was consolidated in Belzona 9382 Release Film and allowed to cure. Once cured the Belzona 9382 release Film was removed.

Application of the Belzona Superwrap II system to this pipe provides a long term repair solution which will restore strength as well as avoiding further external corrosion to the pipe.
