# BELZONA SUPERWRAP II PATCHES SEAWATER BULK MEDIA FILTER VESSEL

ID: 5574

Industry: Oil & Gas  
Application: SOS-Ships and Offshore Structures

Customer Location: Gulf of Mexico, USA  
Application Date: March 2015

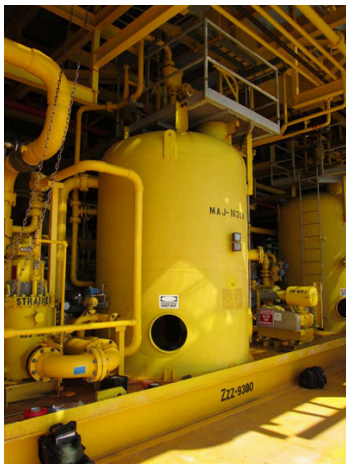
Damage to the external part of the bottom of the vessel due to corrosive environment and seawater transported in the vessel.

Seawater bulk media filter vessel on offshore Oil and Gas platform.
