# STRUCTURAL REINFORCEMENT TO NAPHTHA TOWER WITH BELZONA TECHNOLOGY

ID: 5577

Customer Location: Refinery, Brazil

Naphtha Accumulator

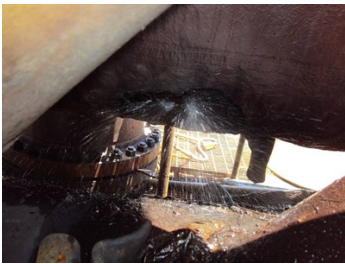
Leaking naphtha due to the presence of holes in the inferior generatrix.

- \* Naphtha leak at the lower generatrix ,
- \* Installation of the structural reinforcement of the cover with Belzona 1511 ,
- \* Structural reinforcement installed in the lower generatrix with Belzona 1391 ,
- \* Completed application ,
