BELZONA REPAIRS A LARGE HYDRAULIC RAM

ID: 558

Industry: Oil & Gas
Application: MPT-Mechanical Power Transmission

Eight meter hydraulic ram of a transport winch

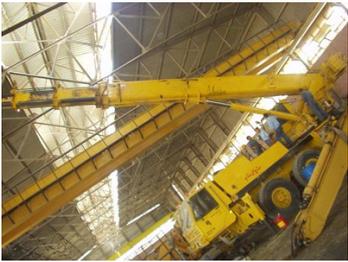
- * General view of the hydraulic ram ,
- * Scores on the ram ,
- * The ram after repair ,
- * Finishing the surface then cleaning it ,

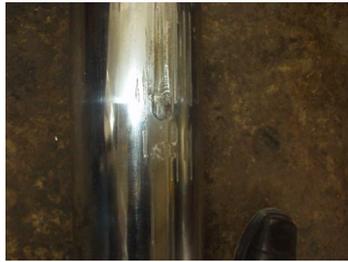
Deep and wide scores in many areas of the ram.

There were scores in many areas of the ram causing many leakages and fluid losses. Belzona saved the replacement costs of the
