# BELZONA REPAIRS A LARGE HYDRAULIC RAM

ID: 558

Eight meter hydraulic ram of a transport winch

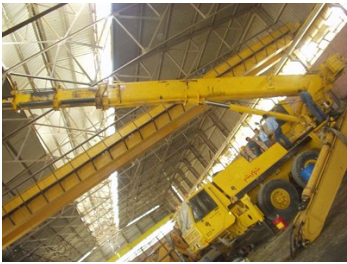
- \* General view of the hydraulic ram ,
- \* Scores on the ram ,
- \* The ram after repair ,
- \* Finishing the surface then cleaning it ,
