# BELZONA AIDS SEALING OF VJ COUPLINGS

ID: 5583

Customer Location: FPSO, North Sea, UK  
Application Date: May 2014 ongoing

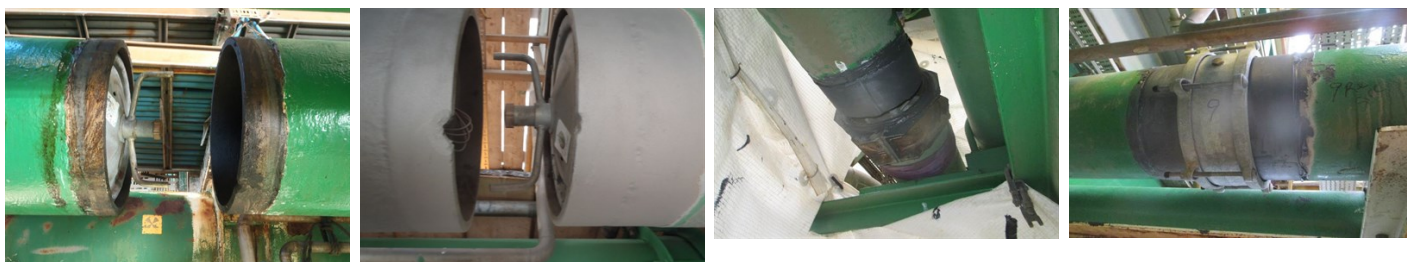
## Photograph Descriptions

Corrosion on pipeline prevented VJ coupling from sealing correctly.

- \* Corroded pipe ends ,
- \* After grit blasting the corrosion pitting clearly evident ,
- \* Former in place ,
- \* Coupling re-installed on smooth Belzona formed pipe ends ,

Application was carried out in accordance with modified version of Belzona Know-How System Leaflet MPT-2. A former was used to rebuild corrosion pitting and to create smooth and accurate landings for the VJ coupling.

The use of Belzona allowed for a quick, hot work free repair to be completed. The corrosion resistant properties of Belzona 1151 will eliminate future corrosion issues ensuring a permanent seal at this joint. This has become a standard procedure for repairing VJ coupled joints with 4" & 6" pipelines repaired using same procedure.
