BELZONA REPAIRS CUI ON A TRANE CHILLER

ID: 5588

Application: VPF-Valves, Pipes and Fittings

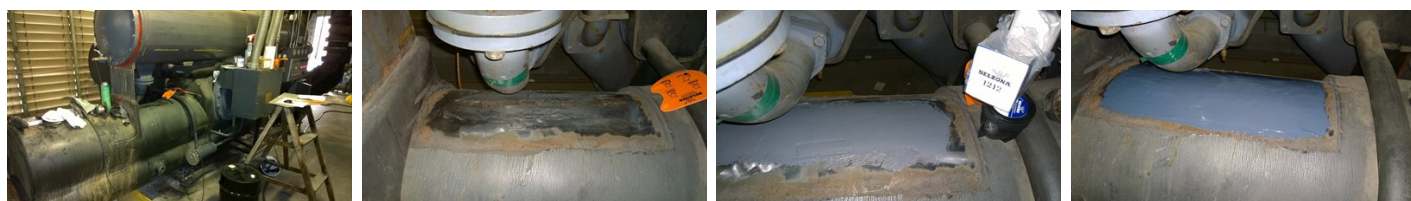
Photograph Descriptions

0.2 inch (5 mm) deep corrosion under insulation threatened to perforate the shell of this chiller. Condensation was traveling through an ineffective seam and pooling in a trough between two sections of foam insulation. This section of the shell experienced almost continual immersion and the attendant corrosion rates.

- * The application area after the insulation has been removed. ,
- * The corrosion was concentrated along a linear trough formed by the rubber insulation. ,
- * The shell fared back out with Belzona 1212. ,
- * The finished repair ready for insulation. ,

This application was performed using a modified version of Belzona Know-How System Leaflet VPF-1 & VPF-2.

The Belzona repair was significantly faster and less expensive than replacement, did not require any down time, and most importantly actually prevents a reoccurrence of the same problem. This chiller is now better than new.
