BELZONA 3411 SOLVES CORROSION PROBLEM FOR NATURAL GAS

Customer Location: Gas Purification Plant, South East of China

Application: GSS-Gaskets, Seals and Shims

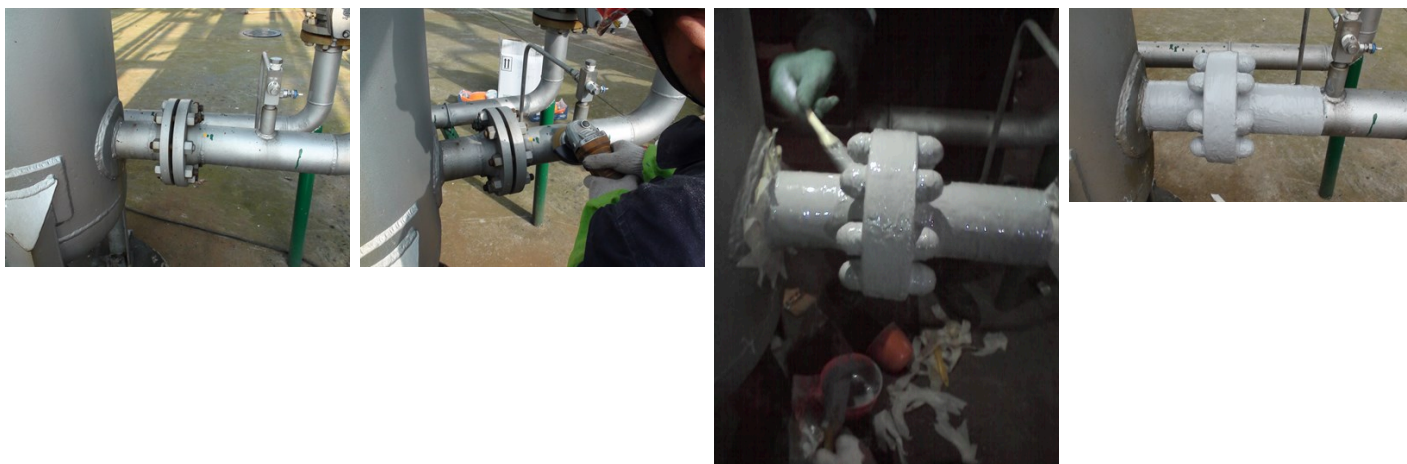
Photograph Descriptions

Corrosion around the flanged connections, bolts and welding area.

- * Corroded flange ,
- * Surface preparation ,
- * Application of Belzona 3411 by brush ,
- * Completed application ,

A Flange (DN100) on the pipework of a purification unit handling triethylene glycol.

The application was carried out in accordance with Belzona Know-How System Leaflet GSS-11.

The Belzona 3411 encapsulating system provides a complete corrosion protection for flanges, fastenings and associated pipes. It is

also as a preventive system which helps improving and facilitating further monitoring and inspection due to the peelable and re-sealable properties. The customer is very satisfied with this innovative solution.
