# BELZONA REPAIRS PVC PUMP

Industry: General Industry  
Application: CEP-Centrifugal Pumps  
Substrate: PVC  
Products: \* Belzona® 1111 (Super Metal) ,

Customer Location: Construction company - Egypt  
Application Date: September 2003

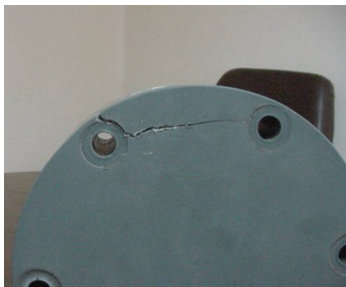
Cracked casing

- \* The crack in the PVC pump ,
- \* Stabilising the crack ,
- \* Cracks after preparation ,
- \* Cracks repaired ,

Application was carried out in accordance with a modified version of Belzona Know-How System leaflet CEP-6. The cracks were stabilized by drilling and widening it then filled with Belzona® 1111.
