# BOW THRUSTER TUNNEL PROTECTED

ID: 5600

Industry: *Marine*  
Application: *SOS-Ships and Offshore Structures*

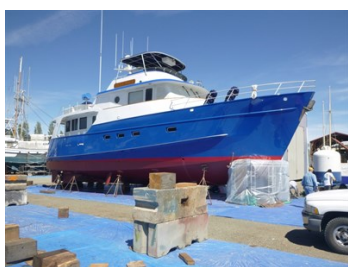
- \* Vessel out of water with hutch built around thruster tunnel for containment. ,
- \* Tunnel prepared with abrasive blast. Note significant pitting on upper surfaces. ,
- \* Belzona 1311 applied to pitted areas as seen from inside vessel. ,
- \* Two coat application of Belzona 1321. Bottom paint will be lapped over Belzona 1321 at tunnel edge. ,

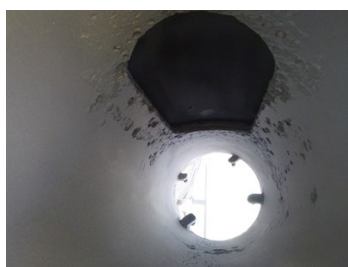
*Thruster tunnel was pitted and eroded in areas near thruster propulsion unit. Bi-metallic corrosion was also a component of the deterioration.*

Tunnel was prepared by first removing several layers of bottom paint and then abrasive blasting to achieve a 3 mil profile. Belzona 1311 was applied to fill the pitting and erosion prior to the application of 2 coats of Belzona 1321.
