# BELZONA REPAIRS TRANSFORMER COOLER

ID: 5601

Customer Location: Electricity Substation, USA

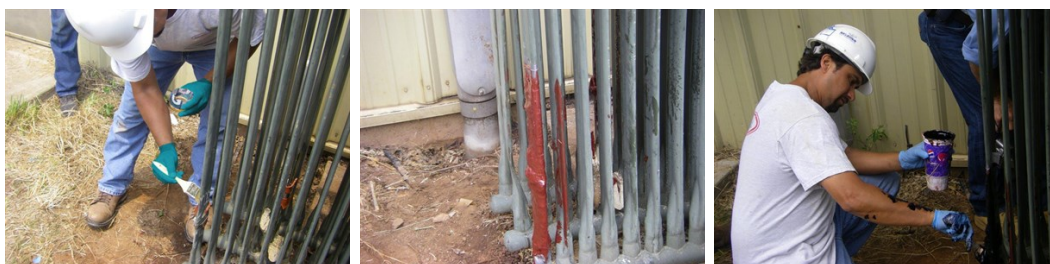
The cooler on this transformer had a tree growing through it; the customer cut it down with a chainsaw. In the process, they cut the cooler with the chainsaw as well.

- \* Preparing the surface ,
- \* Belzona 2121 (red) applied over the reinforcement tape ,
- \* Finalizing the repair with Belzona 2121 (black) ,

The application was carried out in accordance with a modified version of Belzona Know-How System Leaflet VPF-11. The leaks were repaired with Belzona 2121 and reinforcement tape, similar to a pipe repair.
