BELZONA RAM REPAIR = BIG SAVINGS

ID: 5603

Industry: *General Industry*
Application: *MPT-Mechanical Power Transmission*

Substrate: *Chromed Steel*
Products: ** Belzona 1111 (Super Metal) ,*

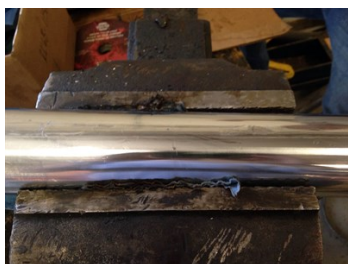
Damaged ram was allowing hydraulic fluid to leak.

- * Damage to the ram ,
- * Cleaning up the edges with a Dremel ,
- * Belzona 1111 post application/waiting to cure ,
- * Completed application to ram and ready for service ,

Hydraulic ram suffering scars in 3 places from being repeatedly struck against the side of a dumpster. Customer was looking for an alternative to replacing the expensive ram.
