# BELZONA RAM REPAIR = BIG SAVINGS

ID: 5603

Industry: *General Industry*  
Application: *MPT-Mechanical Power Transmission*

Substrate: *Chromed Steel*  
Products: *\* Belzona 1111 (Super Metal) ,*

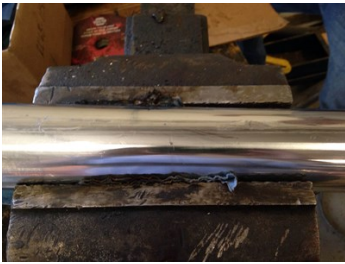
- \* Damage to the ram ,
- \* Cleaning up the edges with a Dremel ,
- \* Belzona 1111 post application/waiting to cure ,
- \* Completed application to ram and ready for service ,

Hydraulic ram suffering scars in 3 places from being repeatedly struck against the side of a dumpster. Customer was looking for an alternative to replacing the expensive ram.
