# Valve Repair and Protection with Belzona

ID: 561

Customer Location: Power plant, Egypt

Application: VPF-Valves, Pipes and Fittings

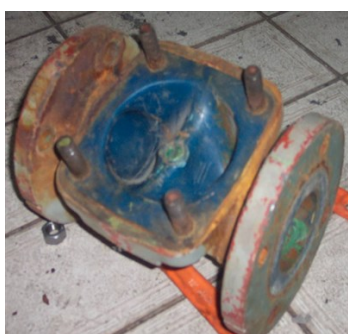
Old polypropylene lining was worn and damaged due to chemical attack.

- \* The valve before repair ,
- \* Former made by casting with Belzona® 5811 ,
- \* Belzona® 1311 applied to the valve ,
- \* Two valves were repaired and protected ,

Application was carried out in accordance with modified version of Belzona Know-How system leaflet VPF-1 and VPF-2. A former was made by casting Belzona<sup>®</sup> 5811 to take the inner shape of the valve. The eroded areas were then rebuilt with Belzona 1311,
