# BELZONA RECOVERS AND COATS ELECTRIC ENERGY POLE

**Industry:** Power  
**Application:** WPA-Wall Problem Areas  
**Substrate:** Concrete  
**Products:** \* Belzona 4141 (Magma-Build) ,  
\* Belzona 4911 (Magma TX Conditioner) ,

**Customer Location:** Electric Energy Utility, Brazil  
**Application Date:** May 2006

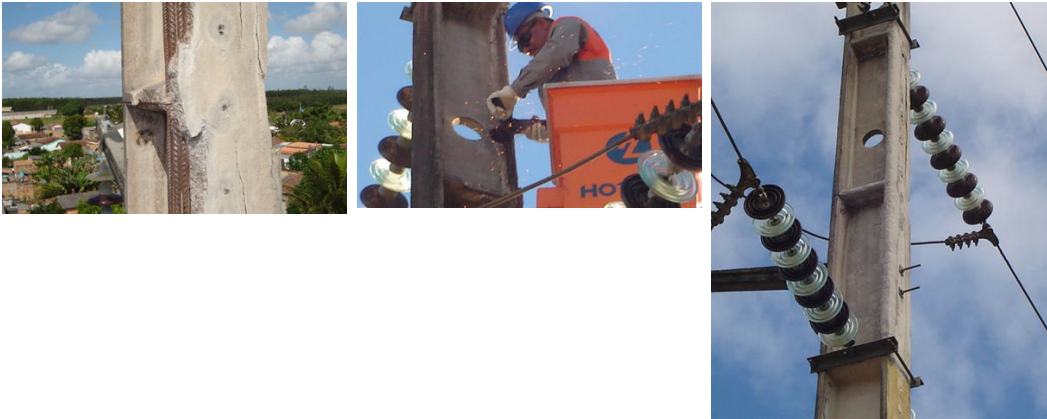
Wear to the poles generated by environmental corrosion and/or excessive compression of the maintenance equipment necessary to raise them.

- \* Pole with damages ,
- \* Surface preparation ,
- \* Completed application ,

The application was carried out in accordance with Belzona Know-How System Leaflet WPA-4. The surface was prepared with various tools, such as a rotating brush, sledgehammer, chopper, emery cloth, drill with mounted tip, and sanding with a rotating wire brush. After this, Belzona 4911 was applied and then Belzona 4141 was used to recover the wear and restore the pole to its structural integrity.
