BELZONA SEALS TRANSFORMER OIL STORAGE TANKS

ID: 5622

Customer Location: Oil supplier, UK
Application Date: June 2015

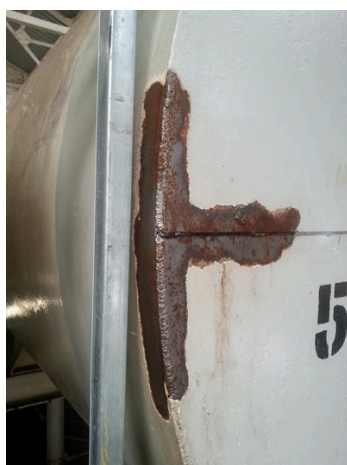
On inspection of the tanks, leaks were evident at the seams. Welding was considered for the repairs, however, due to the area being classed as a confined space and the requirement to take the tanks offline, this was not a desirable option.

- * Transformer oil storage tanks ,
- * Leaking weld ,
- * Completed application with protective coating on top ,
- * Additional repair area ,

Belzona 1212 was used to bond pre-manufactured plates onto the damaged areas of the tanks. Once cured, Belzona 5831 was applied to the plated area to provide long term environmental protection. This application was completed on 6 areas where leaks were identified.
