# BELZONA SEALS TRANSFORMER OIL STORAGE TANKS

Industry: Chemical & Petrochemical  
Application: TCC-Tanks and Chemical Containment Areas

Customer Location: Oil supplier, UK  
Application Date: June 2015

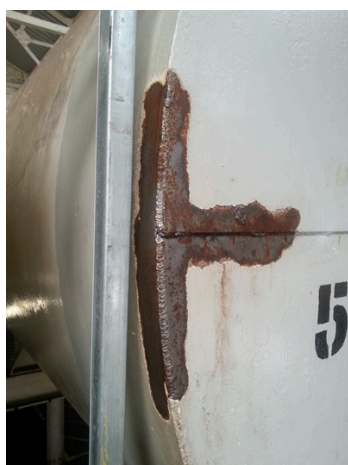
On inspection of the tanks, leaks were evident at the seams. Welding was considered for the repairs, however, due to the area being classed as a confined space and the requirement to take the tanks offline, this was not a desirable option.

- \* Transformer oil storage tanks ,
- \* Leaking weld ,
- \* Completed application with protective coating on top ,
- \* Additional repair area ,

The application was carried out in accordance with Belzona Know-How System Leaflet TCC-1. After the initial surface preparation,

Belzona 1212 was used to bond pre-manufactured plates onto the damaged areas of the tanks. Once cured, Belzona 5831 was applied to the plated area to provide long term environmental protection. This application was completed on 6 areas where leaks were identified.
