# BELZONA PLATE BONDING REPAIRS TO REACTION TANK

ID: 5624

Application: TCC-Tanks and Chemical Containment  
Areas

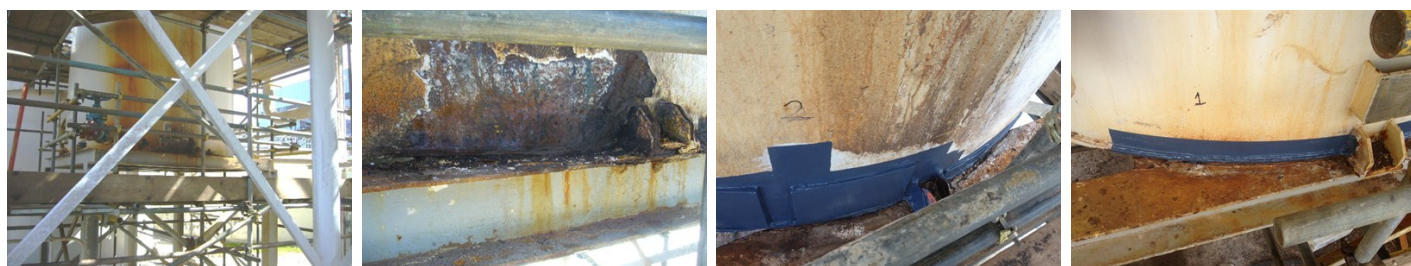
## Photograph Descriptions

- \* Tank with scaffold erected ,
- \* Thin wall area ,
- \* & 4. Plate bonded and overcoated ,

Tank experiencing external corrosion due to rainwater sitting around the lower edges of the outer wall. The external paint system had failed and the tank was going thin wall in places.

The application was carried out in accordance with Belzona Know-How System Leaflet TCC-1. After preparing the area, plates were bonded in place using Belzona 1111 before being overcoated with Belzona 1321 to provide corrosion protection.
