BELZONA SAVES A CRUSHED CRUSHER

Industry: Mining & Quarrying
Application: FPA-Floor Problem Areas
Substrate: Concrete
Products: * Belzona 1221 (Super E-Metal) ,
* Belzona 4911 (Magma TX Conditioner) ,
* Belzona 4111 (Magma-Quartz) ,
* Belzona 4151 (Magma-Quartz Resin) ,

Customer Location: Mining Plant, USA
Application Date: Fall, 2014

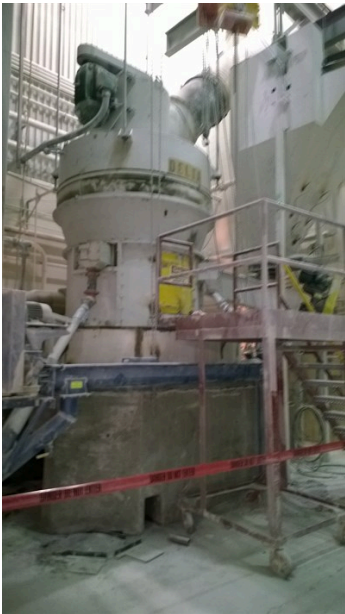
- * 1. Crusher overview ,
- * 2. Series of cracks in foundation ,
- * 3. Prepped, conditioned and injection screws ready to be overcoated with Belzona 4111 ,
- * 4. Injecting Belzona 4151 ,

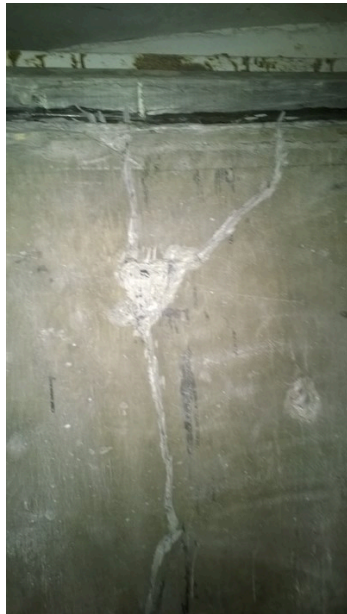
The concrete crusher pedestal developed cracks and caused excessive vibration during crusher operations, leading to premature bearing failure and production to slow down.

Cracks were vee'd out by hand, drilled with injection holes, prepped and faired out with Belzona 4911 and Belzona 4111. Upon initial cure of Belzona 4111, Belzona 4151 resins were injected through the prepared ports under high pressure to chase and fill the underlying voids and cracks. Belzona 1221 was used to seal the injection holes.

Customer had previously tried mortar repairs, but the cracks ran very deep into the concrete and vibration caused the mortar to fail. Resin injection was suggested and customer felt it was a cost effective solution.
