BELZONA SAVES A CRUSHED CRUSHER

Industry: Mining & Quarrying
Application: FPA-Floor Problem Areas
Substrate: Concrete
Products: * Belzona 1221 (Super E-Metal) ,
* Belzona 4911 (Magma TX Conditioner) ,
* Belzona 4111 (Magma-Quartz) ,
* Belzona 4151 (Magma-Quartz Resin) ,

Customer Location: Mining Plant, USA
Application Date: Fall, 2014

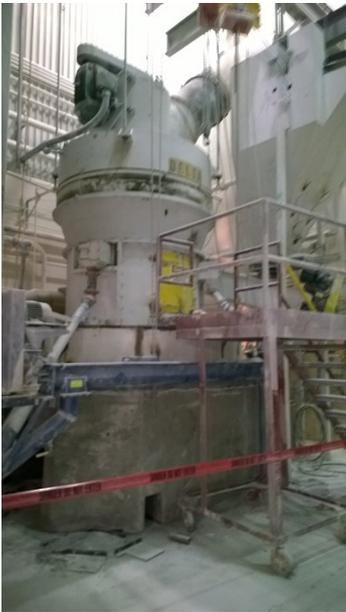
- * 1. Crusher overview ,
- * 2. Series of cracks in foundation ,
- * 3. Prepped, conditioned and injection screws ready to be overcoated with Belzona 4111 ,
- * 4. Injecting Belzona 4151 ,

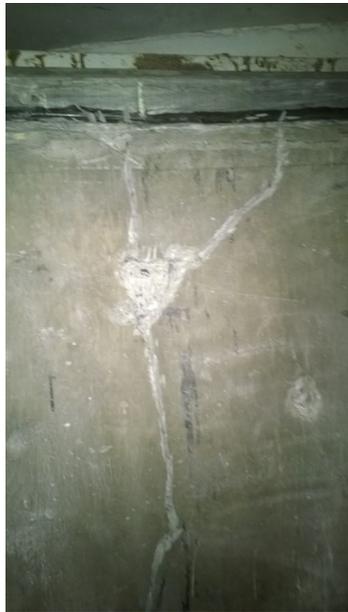
The concrete crusher pedestal developed cracks and caused excessive vibration during crusher operations, leading to premature bearing failure and production to slow down.

Cracks were vee'd out by hand, drilled with injection holes, prepped and faired out with Belzona 4911 and Belzona 4111. Upon initial cure of Belzona 4111, Belzona 4151 resins were injected through the prepared ports under high pressure to chase and fill the underlying voids and cracks. Belzona 1221 was used to seal the injection holes.
