# BELZONA PROTECTS VALVE SEAL AREA

ID: 5640

Customer Location: Hydropower Plant, Honduras  
Application Date: December 2004

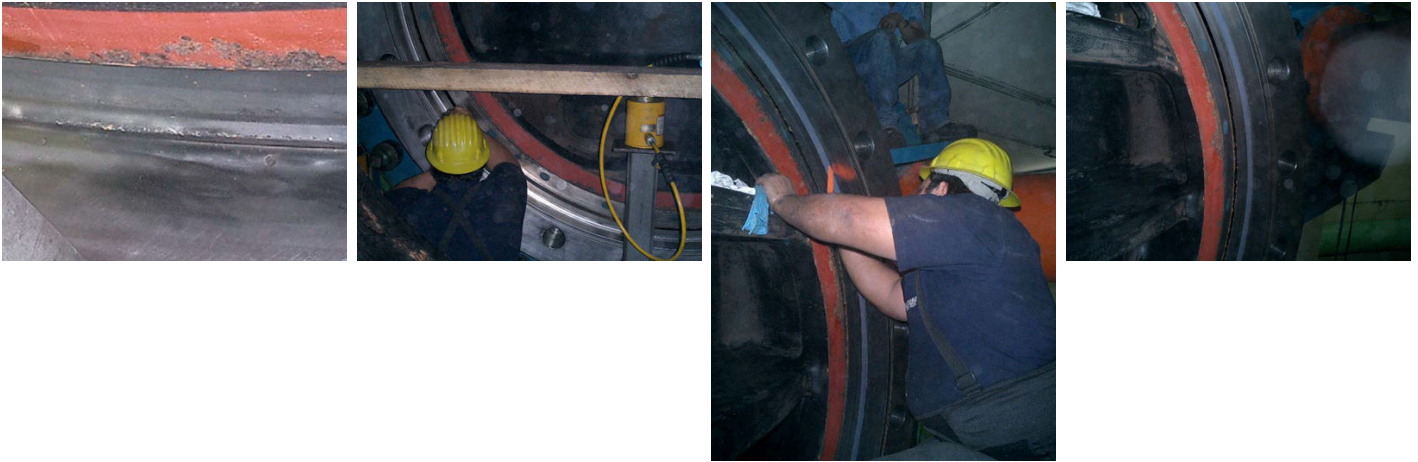
Valve with erosion problems in the perimeter of the seal joint. In certain areas there were small holes but in other areas there were deeper holes.

- \* Valve with cavitation problems ,
- \* Surface preparation ,
- \* Application of Belzona 1321 ,
- \* Completed application ,

The surface was prepared with emery paper and later cleaned with Belzona 9111. The application was carried out in accordance with Belzona Know-How System Leaflet GSS-1. The application formed a protective barrier against water damage.
