BELZONA PROTECTS VALVE SEAL AREA

Customer Location: Hydropower Plant, Honduras
Application Date: December 2004

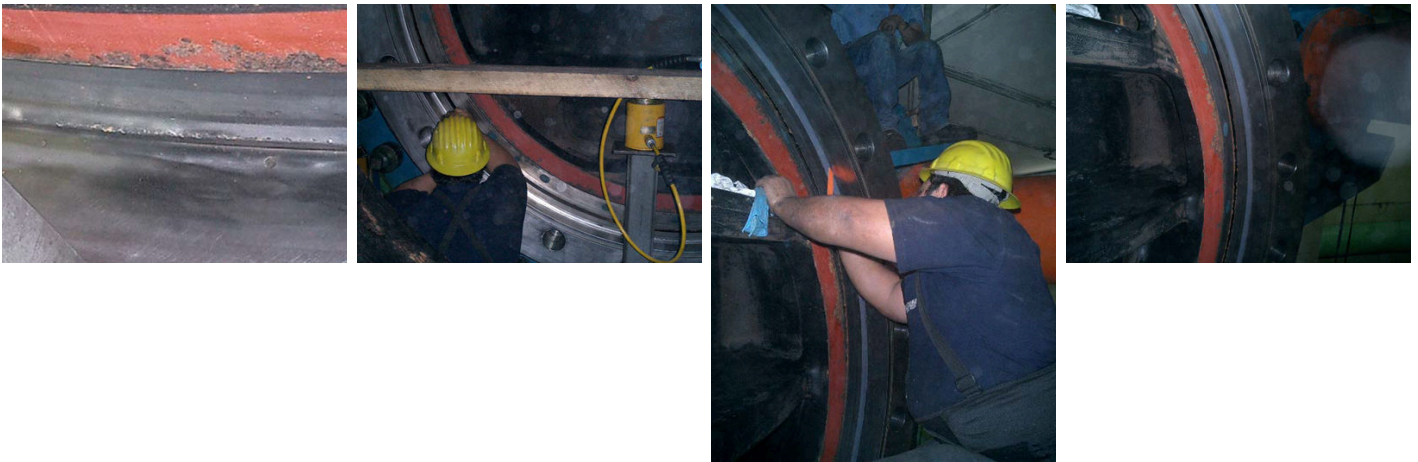
Valve with erosion problems in the perimeter of the seal joint. In certain areas there were small holes but in other areas there were deeper holes.

- * Valve with cavitation problems ,
- * Surface preparation ,
- * Application of Belzona 1321 ,
- * Completed application ,

The surface was prepared with emery paper and later cleaned with Belzona 9111. The application was carried out in accordance with Belzona Know-How System Leaflet GSS-1. The application formed a protective barrier against water damage.
