BELZONA KEEPS WIND TURBINES SPINNING

Customer Location: Wind Farm, Teesside, UK
Application Date: September, 2014

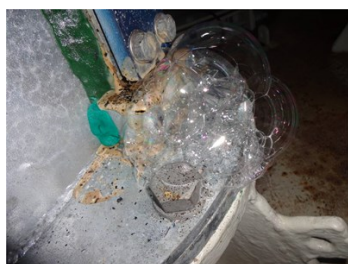
Many of the flanges were not gas tight. Changes in tide led to dangerous gases seeping from the seabed and into the chamber. A temporary sealant had been applied but could not effectively seal the leaks and a permanent solution was required.

- * View of the wind farm ,
- * Leaking flange ,
- * Second leaking flange ,
- * Belzona solution applied ,

Belzona, Belzona's UK application division, was signed on to carry out the repairs with the application in accordance with Belzona Know-How System Leaflet VPF-11. After removing the temporary repairs and preparing the surfaces, Belzona 1161 was used to pack the joint and seal the nuts and bolts using caps filled with product. Two coats of Belzona 5831 were applied onto the flange tops and bottoms to ensure a lasting protection and to eliminate any risk of leaks.

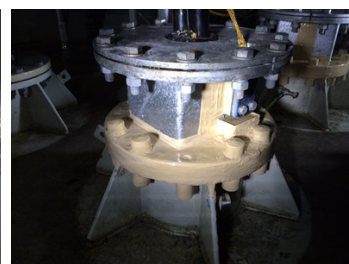
surface-tolerant leak sealing system. After more than a year in service, the repair is performing well with no reported leaks or damage to the flanges. The use of a surface-tolerant composite and coating ensured that the repair could be carried out quickly regardless of surface moisture or contamination as these materials bond exceptionally well to oily or greasy surfaces and even underwater.
