# BELZONA SYSTEM PROTECTS FLANGES AND BOLTS FROM CORROSION

ID: 5643

Customer Location: *Steel Plant, Taiwan*  
Application Date: *August 2014*

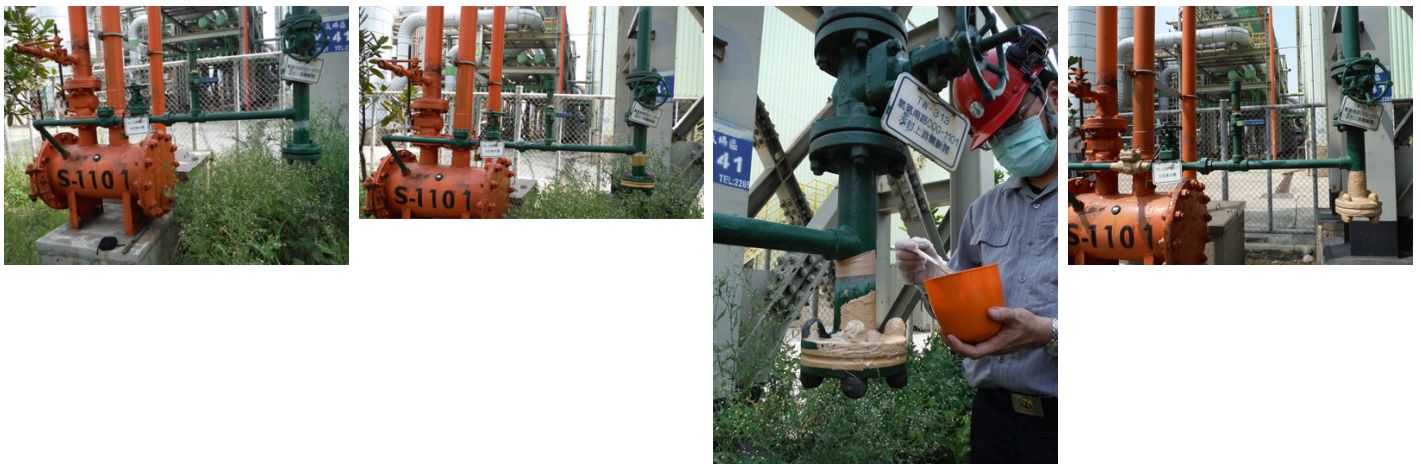
*The flanges and bolts were suffering from corrosion problems due to high humidity from the nearby coast.*

- \* Overview of the fire extinguishing system. ,
- \* Applying Belzona 8411 as a corrosion inhibitor after the surface preparation. ,
- \* Applying Belzona 3411. ,
- \* Completed application. ,

The vertical shut-off valve's flange was suffering from corrosion caused by trapped water which leads to frequent equipment

replacement. Applying the Belzona 3411 system protects the fire extinguishing system from corrosion and weathering.

The application was carried out in accordance with Belzona Know-How System Leaflet GSS-11.
