BELZONA SYSTEM PROTECTS FLANGES AND BOLTS FROM CORROSION

Industry: Steel & Metal Processing
Application: GSS-Gaskets, Seals and Shims
Substrate: Carbon Steel
Products: * Belzona 3411 (Encapsulating Membrane) ,
* Belzona 8411 ,

Customer Location: Steel Plant, Taiwan
Application Date: August 2014

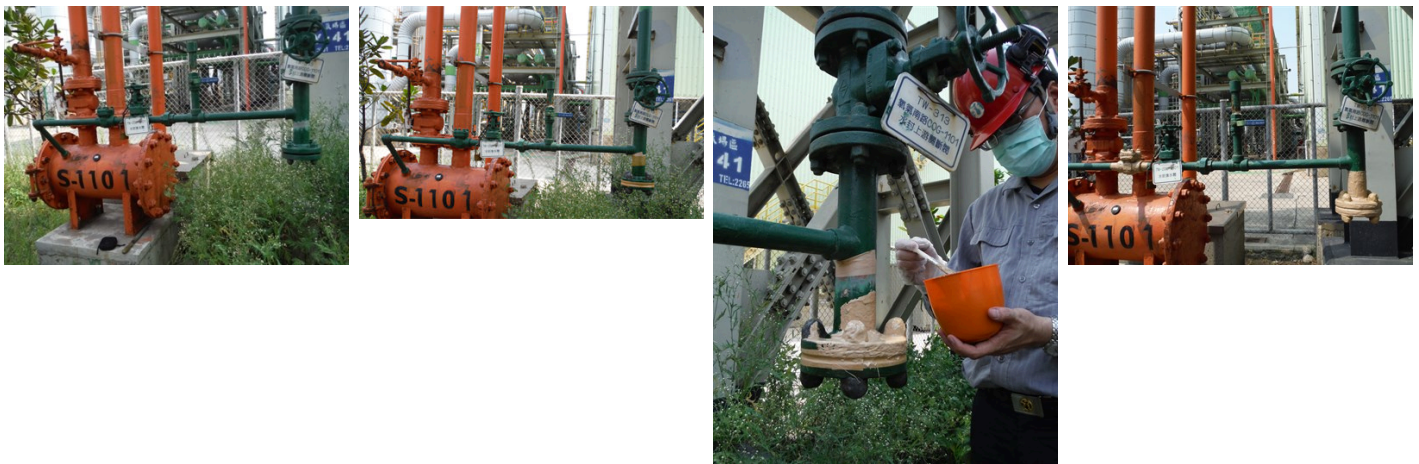
Photograph Descriptions

The flanges and bolts were suffering from corrosion problems due to high humidity from the nearby coast.

- * Overview of the fire extinguishing system. ,
- * Applying Belzona 8411 as a corrosion inhibitor after the surface preparation. ,
- * Applying Belzona 3411. ,
- * Completed application. ,

The vertical shut-off valve's flange was suffering from corrosion caused by trapped water which leads to frequent equipment

replacement. Applying the Belzona 3411 system protects the fire extinguishing system from corrosion and weathering.

The application was carried out in accordance with Belzona Know-How System Leaflet GSS-11.
