# BELZONA FLANGE ENCAPSULATION SYSTEM PROTECTS FIRE SYSTEM

**Industry:** Commercial Facilities  
**Application:** GSS-Gaskets, Seals and Shims  
**Substrate:** Carbon Steel  
**Products:** \* Belzona 3411 (Encapsulating Membrane) ,  
\* Belzona 8411 ,

**Customer Location:** Cogeneration plant, Taiwan  
**Application Date:** October, 2014

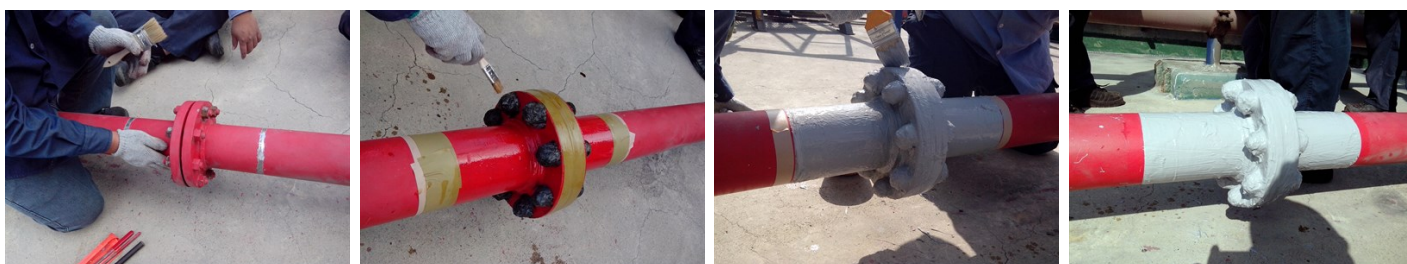
*The flange and bolts were suffering from corrosion problems due to the coast nearby.*

- \* Overview of fire extinguishing system ,
- \* Surface Preparation and applying 8411 as a corrosion inhibitor. ,
- \* Applying Belzona 3411 ,
- \* Application completed ,

The application was carried out in accordance with Belzona Know-How System Leaflet GSS-11.

The plant is near the coast and the flange and bolts are exposed to humid environment which caused corrosion problem, such as crevice corrosion. Applying Belzona 3411 system protects the fire extinguishing system from corrosion whilst allowing easy inspection when required.
