No Job is Too Small for Belzona

ID: 565

Application: *ENC-Engines and Casings*

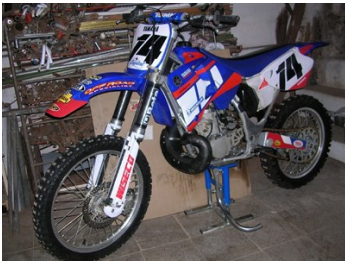
- * Yamaha YZ 250 ,
- * Broken thread ,
- * Completed work ,
- * See the rebuilt fillet ,

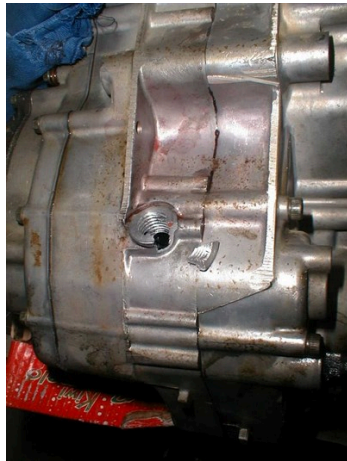
Activities during a motocross race caused a stripped thread. Piece of equipment quite expensive.
