BELZONA REPLACES PTFE LINING AND CUTS DOWNTIME

ID: 5655

Customer Location: *Chemical Plant, Ferrara, Italy*
 Application Date: *April, 2015*

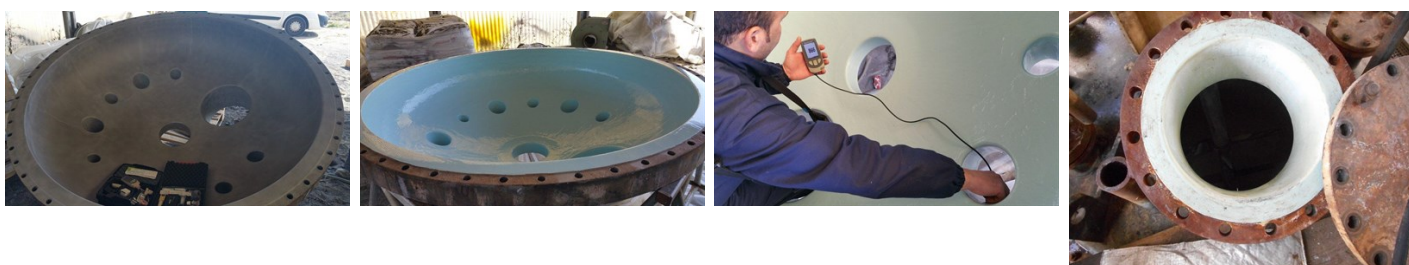
Photograph Descriptions

The original hot applied PTFE Lining required maintenance due to localised disbondment. The plant was facing a long downtime as it was not possible to conduct an in-situ repair of such a lining. The customer was looking for a solution that was faster and easier to apply.

- * PTFE lining removed ,
- * Belzona lining applied ,
- * Coating thickness measured ,
- * Inspected after 6 months in service ,

The application was carried out in accordance with Belzona Know-How System Leaflet TCC-5 for protecting and rebuilding steelwork. After grit blasting to SA 2.5, a two-coat system of Belzona 1593 was hand applied to an area of 25 m².
