# BELZONA PROTECTS NEW VACUUM PUMPS

ID: 5657

Industry: *Pulp & Paper*  
Application: *PDP-Positive Displacement Pumps*

Customer Location: *Paper Machine Manufacturer, France*  
Application Date: *June 2003*

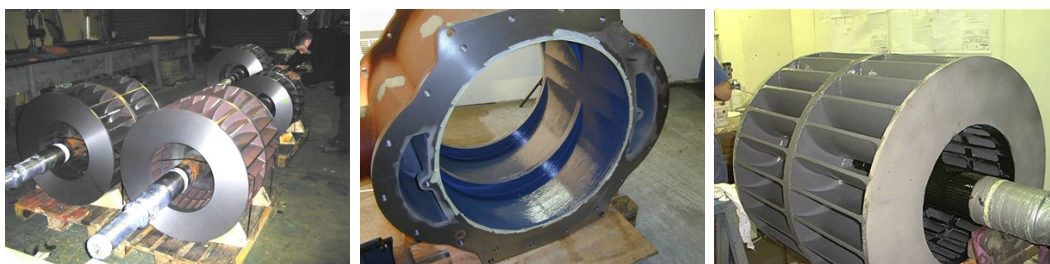
*The pumps rapidly deteriorate in service due to contamination of the water seal with acid leading to severe erosion corrosion. Preventive treatment required to extend service life of the pumps.*

\* 1. New rotors 2. Protected pumps 3. Application on a rotor ,

New vacuum pumps at paper machine manufacturer in need of erosion and corrosion protection.

Application was carried out in accordance with Belzona System Leaflet PDP-5.
