# BELZONA REPAIRS AND PROTECTS CORRODED SHELL

Application: *HEX-Heat Exchangers*

Customer Location: *Petrochemical facility, Egypt*

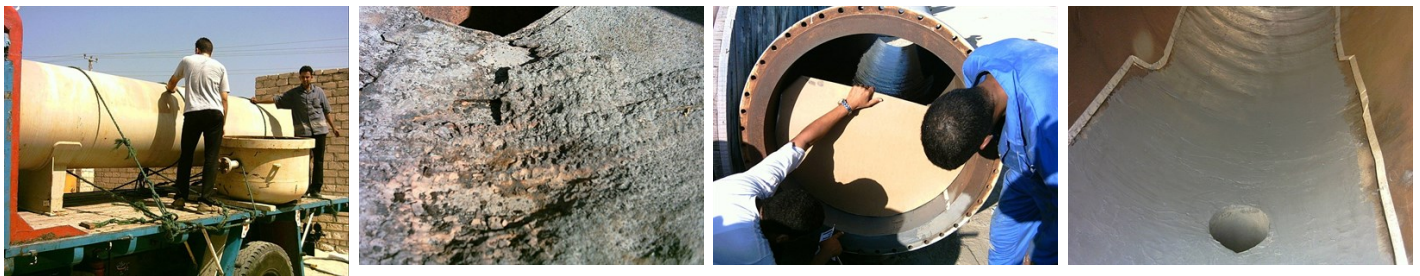
*Shell and dished end were highly corroded due to chemical attack that resulted in critical wall thickness reduction in the shell.*

- \* General view of the shell and cover. ,
- \* The corroded surface inside the shell. ,
- \* Forming the applied Belzona® Marine Metal. ,
- \* Belzona® Marine Metal rebuild successfully completed. Belzona® 1321 applied to provide overall corrosion protection. ,

Application was carried out in accordance with Belzona Know-How System Leaflets HEX-2 and HEX-3. Belzona® Marine Metal was used to restore the original dimensions then Belzona® 1321 was used to protect the restored area from any further corrosion.

Repair completed quickly and safely, thickness of the shell was restored to the original dimensions with no heat and no special tools. As measured weekly, the vessel stopped losing wall thickness, resisting chemical attack and still in excellent condition.
