BELZONA REPAIRS AND PROTECTS CORRODED SHELL

ID: 566

Application: HEX-Heat Exchangers

Customer Location: Petrochemical facility, Egypt

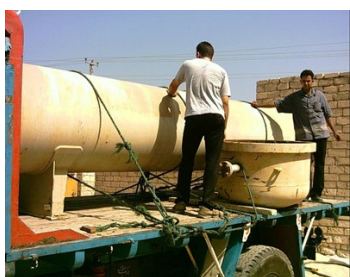
- * General view of the shell and cover. ,
- * The corroded surface inside the shell. ,
- * Forming the applied Belzona® Marine Metal. ,
- * Belzona® Marine Metal rebuild successfully completed. Belzona® 1321 applied to provide overall corrosion protection. ,

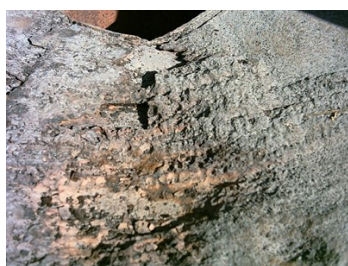
Shell and dished end were highly corroded due to chemical attack that resulted in critical wall thickness reduction in the shell.
