BELZONA REPAIRS AND PROTECTS CORRODED SHELL

Application: HEX-Heat Exchangers

Customer Location: Petrochemical facility, Egypt

Heat exchanger shell

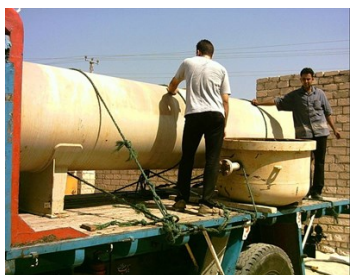
- * General view of the shell and cover. ,
- * The corroded surface inside the shell. ,
- * Forming the applied Belzona® Marine Metal. ,
- * Belzona® Marine Metal rebuild successfully completed. Belzona® 1321 applied to provide overall corrosion protection. ,

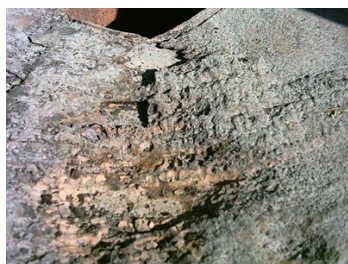
Shell and dished end were highly corroded due to chemical attack that resulted in critical wall thickness reduction in the shell.
