# FIRE TRUCK PUMP GETS NEW LIFE WITH BELZONA

ID: 5660

Customer Location: *Fire Department, Texas, USA*  
Application Date: *2013*

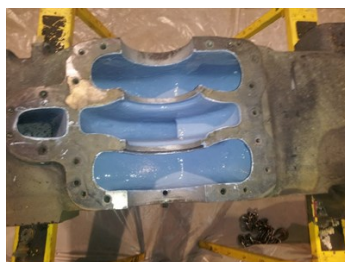
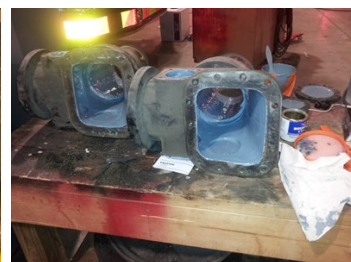
*The pump had suffered severe corrosion due to intermittent use.*

- \* View of the fire truck ,
- \* Blasted pump ,
- \* Coated pump ,
- \* Coated valve body ,

The application was carried out in accordance with Belzona Know-How System Leaflets CEP-1 and CEP-3. Pump was blasted and repaired with Belzona 1111 prior to being coated with Belzona 1341.
