BELZONA PROTECTS A STERN TUBE (NON-BEARING AREAS) ON A A US NAVY SHIP

ID: 5664

Stern Tube on a U.S. Navy Ship

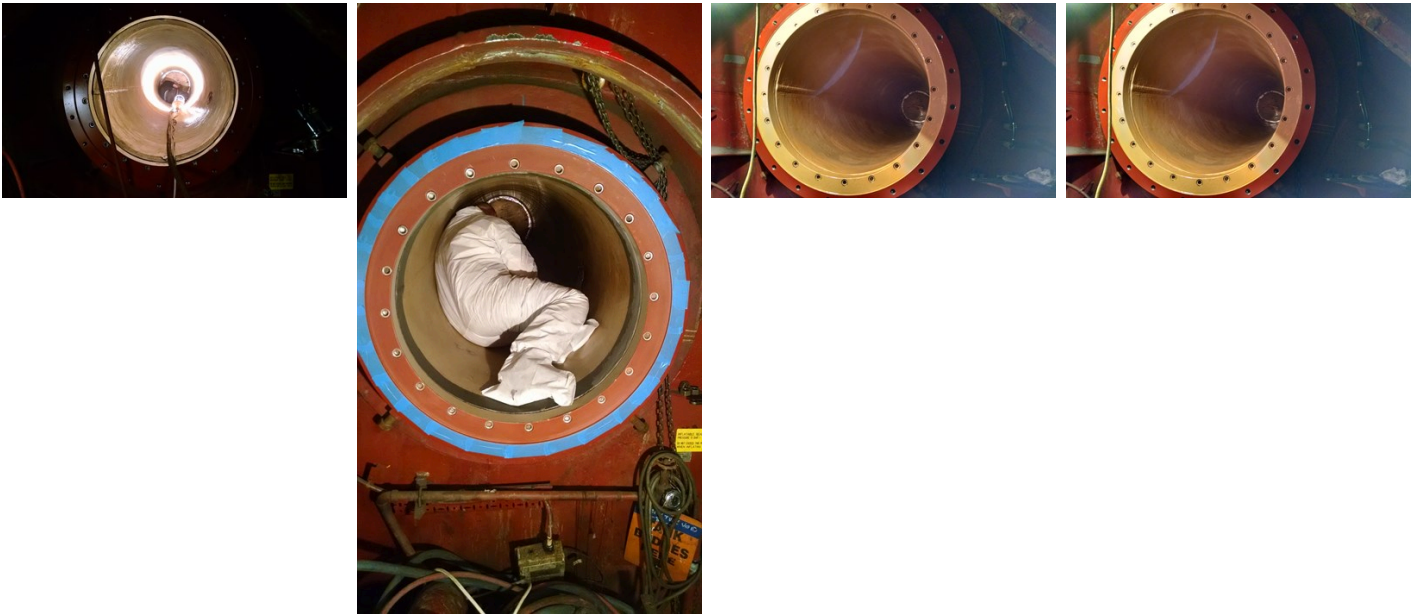
Photograph Descriptions

The U.S. Navy required superior protection against erosion and corrosion in the non-bearing area of the stern tube when the ship was dry docked.

- * Stern Tube Preparation ,
- * Stern Tube Coating ,
- * Completed Stern Tube Coating ,

Areas in stern tube were spot repaired with Belzona 1111 and then coated with a brush.
