# BELZONA SUPERWRAP II ENSURES THE SAFETY OF AN OFFSHORE PLATFORM

ID: 5666

6" diameter riser on an offshore platform.

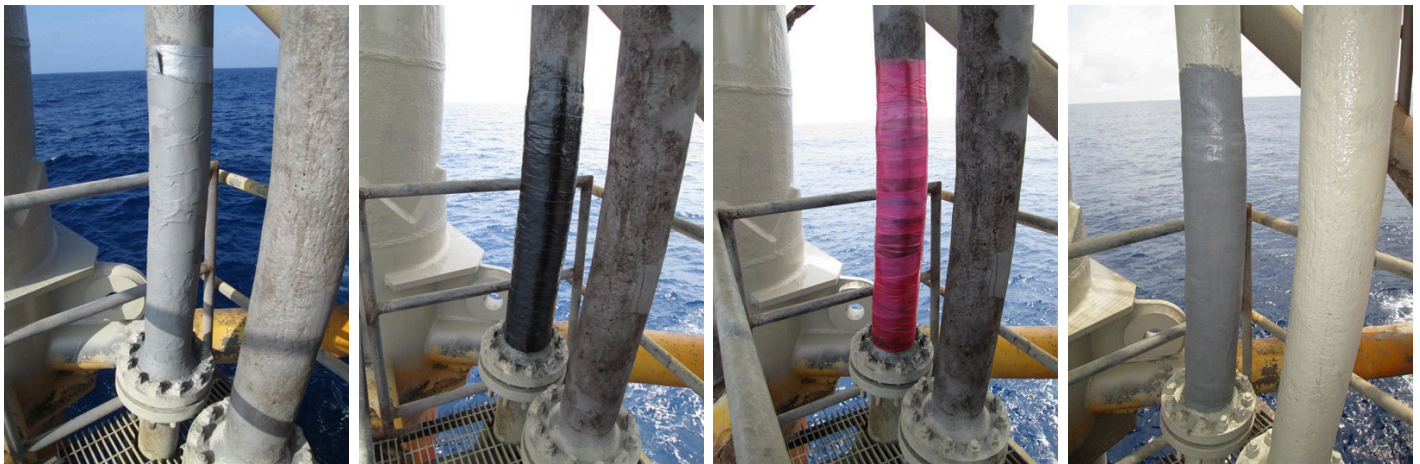
*The integrity of the riser was compromised due to severe damage caused by external corrosion. The asset owner needed to protect the surface of the riser without any interruption to the operation. Hot work was not an option.*

- \* Belzona 1121 applied to fill pitting ,
- \* Four wraps (8 layers) of Belzona 1982 applied ,
- \* Belzona 9382 applied to consolidate repair during cure ,
- \* Complete application - Belzona Superwrap II repair overcoated with Belzona 1121 prior to application of urethane topcoat ,

The substrate was grit blasted to produce a surface cleanliness of SSPC-SP 10 (Near White Metal) with an anchor profile of at least 3 mils (75 microns). The surface was then cleaned and degreased and the condition of the blasted surface was maintained until the application of the repair system. Belzona 1121 was used to fill pitted areas and to restore the original pipe thickness. Belzona 9381 was saturated with Belzona 1982 and applied onto the pipe in 4 wraps (8 layers) in compliance with the engineered design. To consolidate the repair during the curing process, Belzona 9382 was employed. After 24-hour cure, Belzona 9382 was removed. The surface of the cured Superwrap II was washed and sanded, and the pipe was overcoated with Belzona 1121 prior to application of a urethane top coat.
