BELZONA RESTORES OIL & GAS FLOAT CELL VESSEL

ID: 5667

Customer Location: Gulf of Mexico, USA
Application Date: May 2015

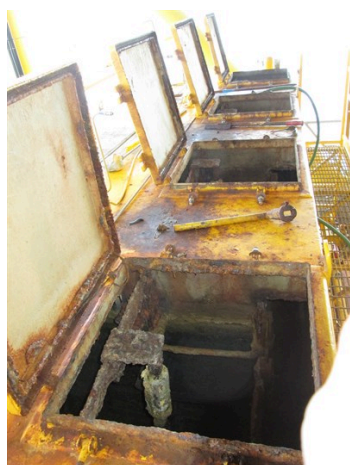
The oil bucket which ran along the length of the vessel was developing frequent through-wall defects. These holes inhibited the float cell from properly separating produced water from oil & gas.

- * Float Cell before. Note oil bucket runs on right hand side of vessel. ,
- * Cold Plate Bonding illustration generated as part of proposal. ,
- * Cold Plate Bonding complete on a portion of the float cell. ,
- * Two coat system of Belzona 5811 installed as a corrosion barrier. ,

The application was carried out in accordance with a modified Belzona Know-How System Leaflet TCC-1 and TCC-3. Belzona 1121 was used to cold-plate bond on both sides of thin-wall/through-wall damaged areas of the oil bucket, and Belzona 5811 was used to coat all internal surfaces for a corrosion barrier.
