# BELZONA EMERGENCY LEAK SEALING

Industry: Oil & Gas  
Application: HEX-Heat Exchangers  
Substrate: Carbon steel  
Products: \* Belzona® 1321 (Ceramic S-Metal) ,

Customer Location: Oil refinery, Egypt  
Application Date: October 2003

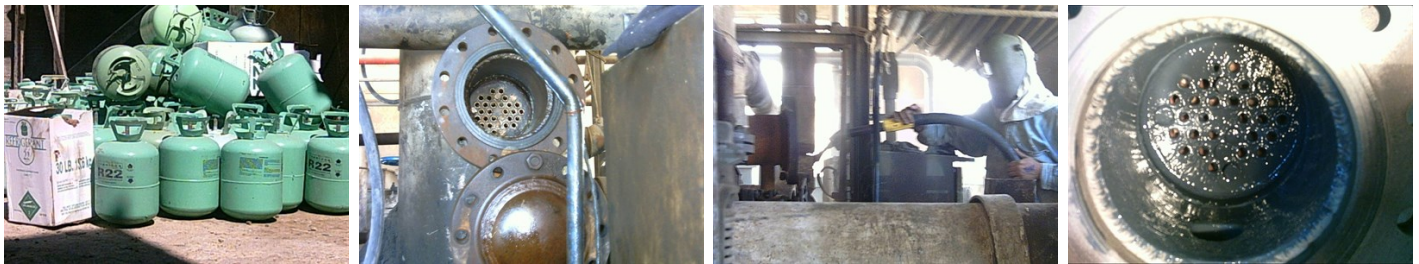
*Bi-metallic corrosion between the tubes and the tube sheet had caused Freon leakage.*

- \* General view of the consumed Freon containers used to replenish leaks. ,
- \* The tube sheet suffering from Freon leakage ,
- \* Surface preparation by grit blasting ,
- \* Belzona® 1321 applied to stop the leakage ,

Tube sheet in nitrogen production unit working at 8 bar

Application was carried out in accordance with Belzona Know-How System Leaflet HEX-3.

Beside the health factors, Belzona has saved about \$35,000 annually for refilling Freon due to leakage, only in three hours of work and \$340 for Belzona products. The repair was completed quickly and safely with out heat.
