BELZONA REBUILD TRENCH DRAIN AT PAPER MILL

ID: 5684

Customer Location: *Paper Mill, Northern Texas, USA*
Application Date: *2014*

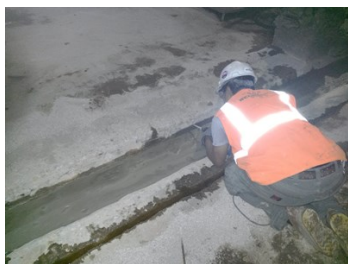
The concrete holding up the grate was so damaged that the grate fell into the trench.

- * Edges being prepared while drain is in use ,
- * Forms used to rebuild edges with Belzona 4111 ,
- * Grate replaced over the trench ,
- * One year later, still performing well ,

The application was carried out in accordance with Belzona Know-How System Leaflet FPA. Loose concrete was chipped away and the edges were ground. A wood former was used to rebuild the edges to the original width and height.
