BELZONA SMOOTHS AIRPORT RUNWAY

ID: 5685

Customer Location: Airport, Northern Texas, USA
Application Date: 2014

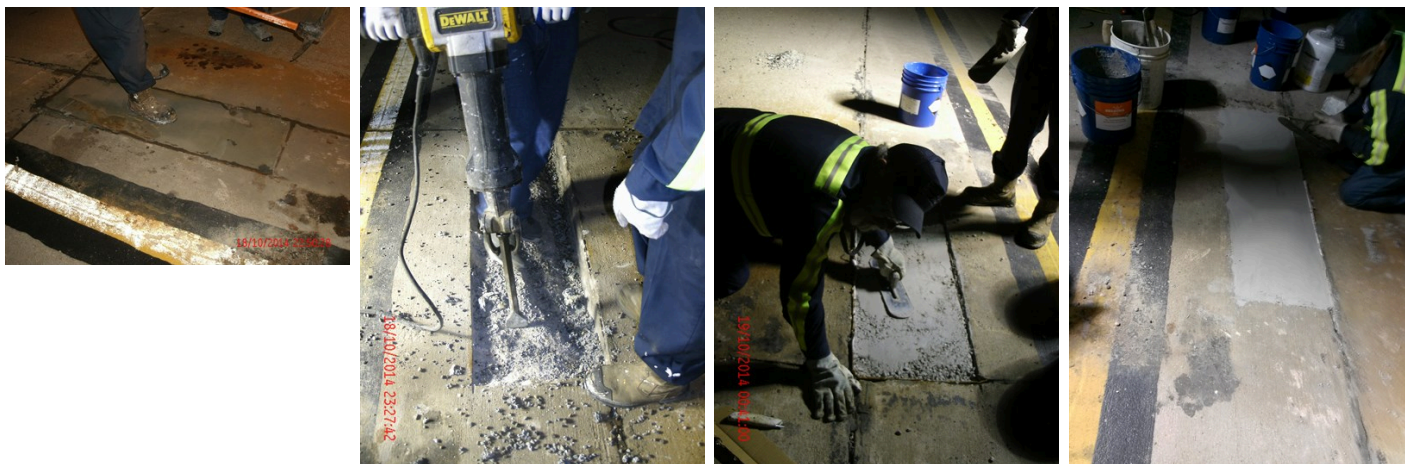
Photograph Descriptions

Prior patching material failed. A steel plate was used to cover the hole.

- * Old patch failed and removed ,
- * Hole prepared for application ,
- * Bulk material to fill the hole ,
- * Finished with pure Belzona 4111 ,

The application was carried out in accordance with Belzona Know-How System Leaflet FPA. Old and loose material was removed. Then, a mixture of gravel and Belzona 4111 was used to bulk up the patch. A batch of pure Belzona 4111 was used to finish the job.
