BELZONA SMOOTHS AIRPORT RUNWAY

ID: 5685

Customer Location: Airport, Northern Texas, USA
Application Date: 2014

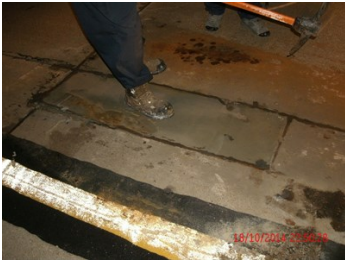
Prior patching material failed. A steel plate was used to cover the hole.

- * Old patch failed and removed ,
- * Hole prepared for application ,
- * Bulk material to fill the hole ,
- * Finished with pure Belzona 4111 ,

The application was carried out in accordance with Belzona Know-How System Leaflet FPA. Old and loose material was removed. Then, a mixture of gravel and Belzona 4111 was used to bulk up the patch. A batch of pure Belzona 4111 was used to finish the job.
