# BELZONA STOPS THE LEAKS ON HVAC TUBES

ID: 57

Industry: *Chemical & Petrochemical*  
Application: *VPF-Valves, Pipes and Fittings*  
Substrate: *Copper*  
Products: *\* Belzona®1111 (Super Metal) ,*

Customer Location: *Petrochemical Plant in Texas, U.S.A.*  
Application Date: *1991*

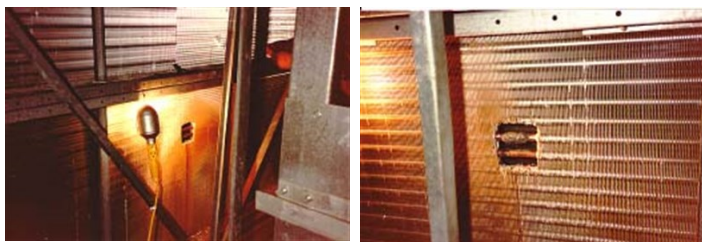
## Photograph Descriptions

*Leaking coolant*

- \* An area was cut to gain access to the leaking pipe ,
- \* Leak stopped with Belzona® 1111 (Super Metal) ,

Tube in HVAC coil

Application was carried out in accordance with Belzona Know-How Leaflet VPF-11a.

After six years the repair is still in place.
