BELZONA STOPS THE LEAKS ON HVAC TUBES

ID: 57

Industry: *Chemical & Petrochemical*
Application: *VPF-Valves, Pipes and Fittings*
Substrate: *Copper*
Products: ** Belzona®1111 (Super Metal) ,*

Customer Location: *Petrochemical Plant in Texas, U.S.A.*
Application Date: *1991*

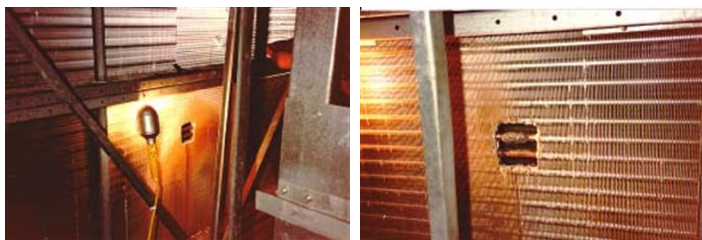
Leaking coolant

- * An area was cut to gain access to the leaking pipe ,
- * Leak stopped with Belzona® 1111 (Super Metal) ,

Tube in HVAC coil

Application was carried out in accordance with Belzona Know-How Leaflet VPF-11a.

After six years the repair is still in place.
