LIVE WATER LEAK CLAMPED WITH BELZONA

ID: 5704

Customer Location: Hospital, Northern Texas, USA
Application Date: 2011

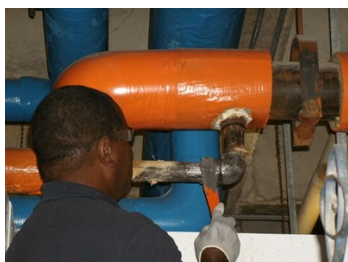
The hot water line was leaking from an expansion tank to the 2" line. The supply of hot water could not be shut off since it fed water to the emergency room.

- * Leaking pipe cleaned ,
- * Clamp ready to go ,
- * Application of Belzona 1111 ,
- * Clamp installed ,

A clamp was fabricated at a machine shop. The clamp had a threaded drain and matched threaded fittings. Belzona 1111 was applied to secure clamp to the hot water line.
