BELZONA BEARING HOUSING REPAIR

ID: 571

Customer Location: Iron and steel manufacturing factory,
Egypt

Exhauster fan bearing housing

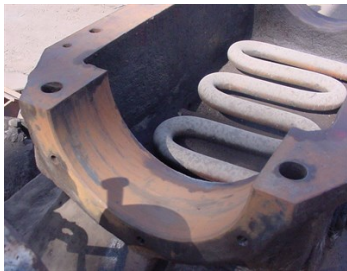
Oversized bearing housing due to bearing failure.

- * General view of the bearing housing ,
- * Rebuilding of bearing housing using forming technique ,
- * Bearing housing after repair ,
- * The upper part of bearing housing repaired ,
